REVEGETATION AND EROSION CONTROL OBSERVATIONS ALONG THE TRANS-ALASKA PIPELINE

1975 Summer Construction Season

L. Johnson, W. Quinn and J. Brown

March 1977

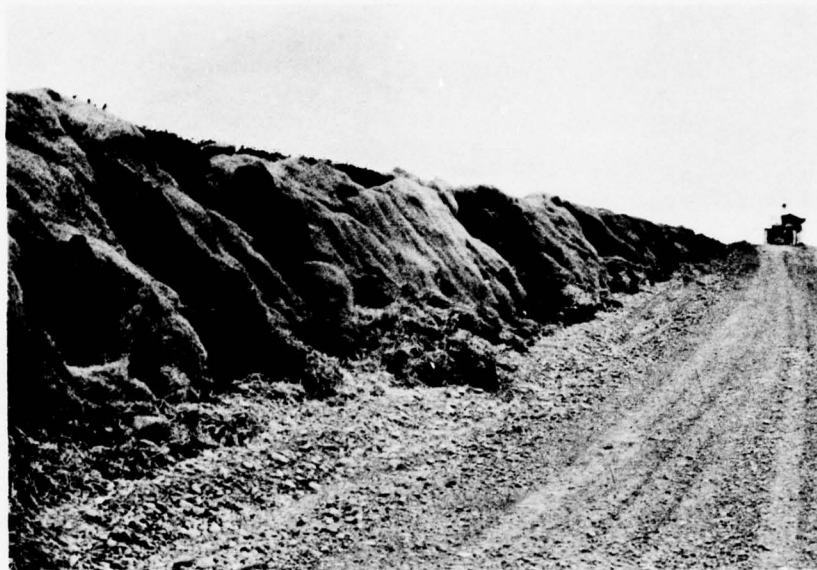
1. A.S. 131.3: Road cut near Franklin Bluffs airport slumping despite excelsior netting. (Plate 1)
- *2. Material sites 127-2.1A and 2.1B: Gravels were hydroseeded but erosion, slumping, development of large cracks, and minimal plant cover persist. (Plate 2)
3. A.S. 122: Happy Valley road cut with ice wedge meltout and slumping. (Plate 3)
4. A.S. 119.1: Slope Mountain material site, hydroseeded and mulched with little growth. (Plate 4)

Plate 1. A.S. 131.3: Road cut near Franklin Bluffs airport slumping despite excelsior netting.

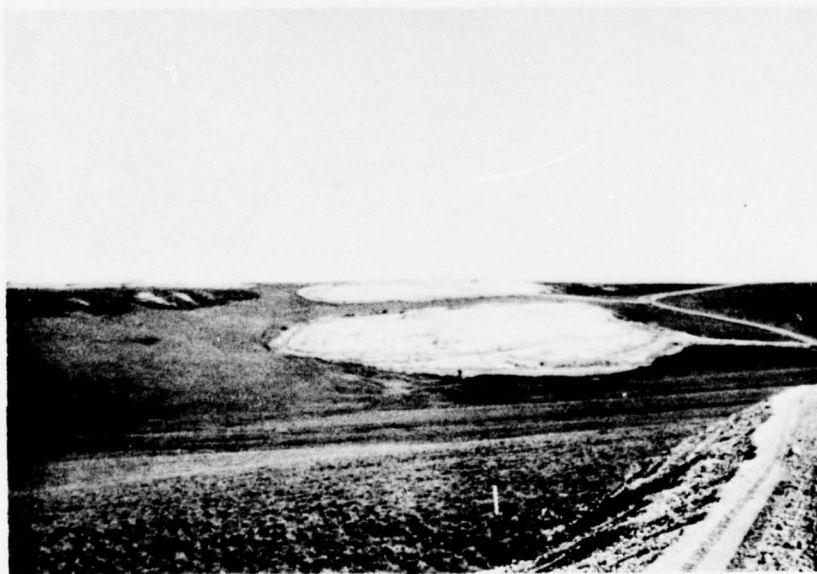
Plate 2. Material sites 127-2.1A and 2.1B: Gravels were hydroseeded but erosion, slumping, development of large cracks, and minimal plant cover persist.

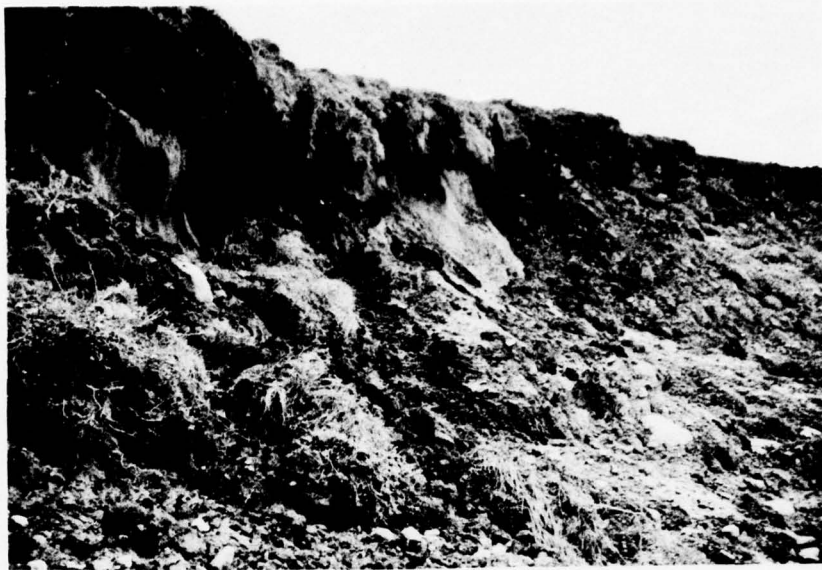
Plate 3. A.S. 122: Happy Valley road cut with ice wedge meltout and slumping.

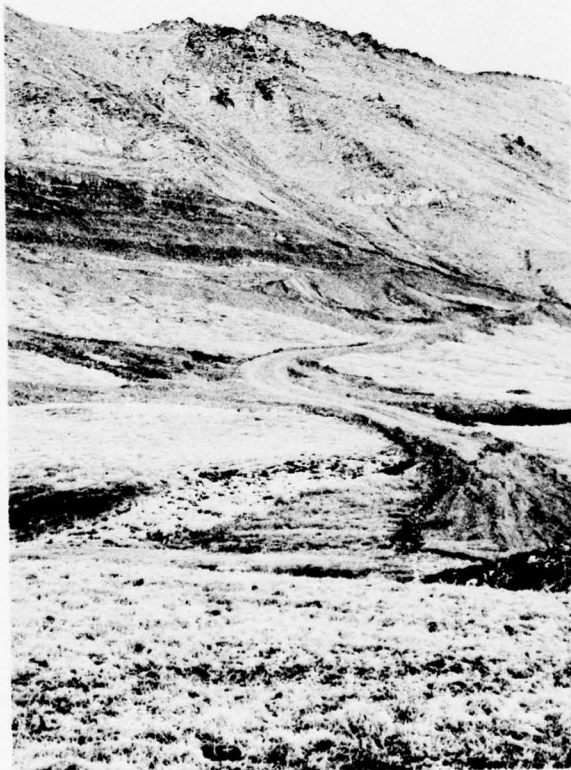
Plate 4. A.S. 119.1: Trail near Slope Mountain material site, hydroseeded and mulched with little growth.

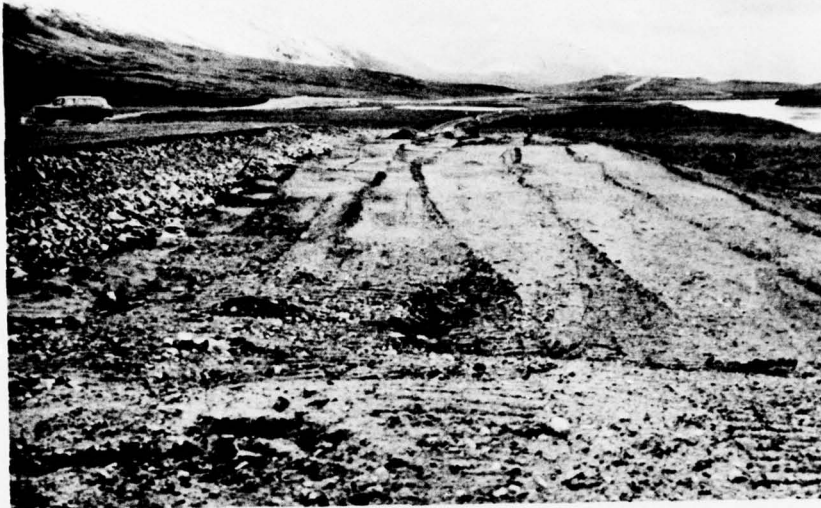
- *5. A.S. 114: Seeded disposal blankets along shoulder of road between Galbraith Lake access road and Atigun River cut. (Plate 5)

Plate 5. A.S. 114: Seeded disposal blankets along shoulder of road between Galbraith Lake access road and Atigun River cut.

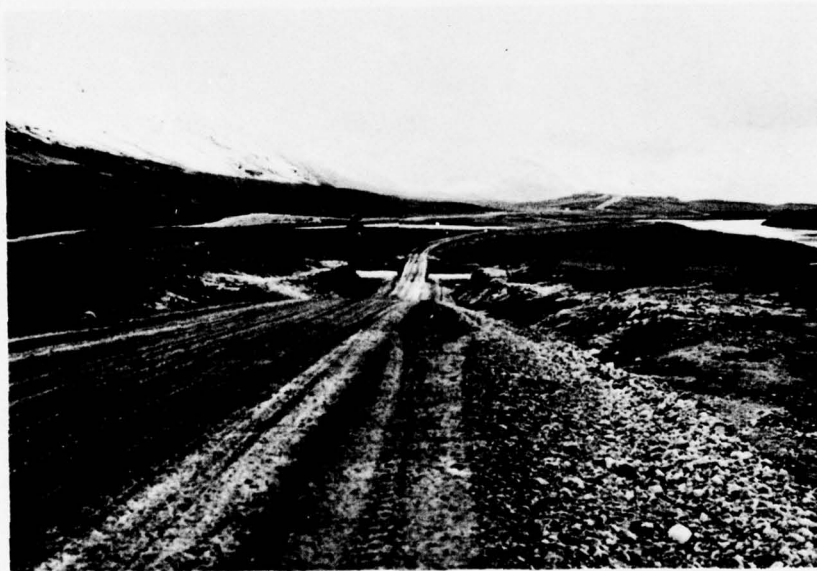
Plate 6. A.S. 114: Near vertical road cut hydroseeded and mulched on north side of Atigun River.

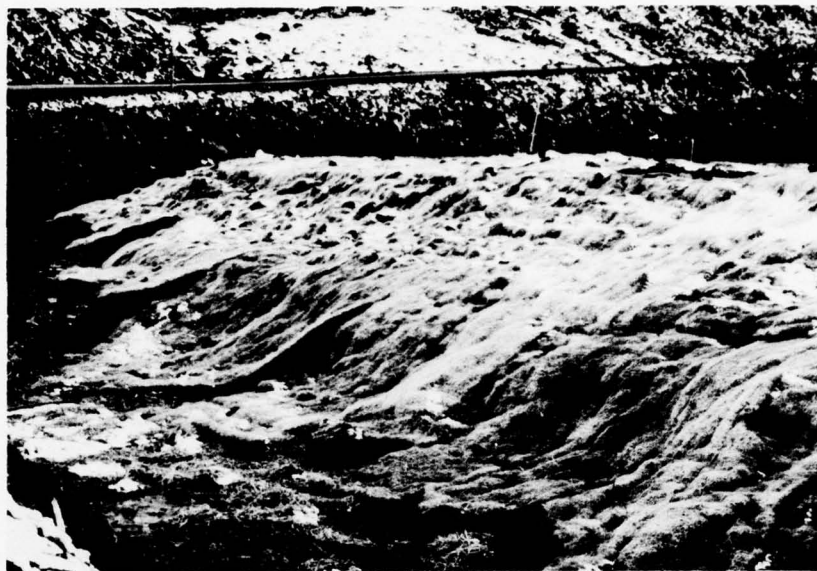
Plate 7. A.S. 110: A number of seeded and mulched slopes along the northern road approach to Atigun Pass.

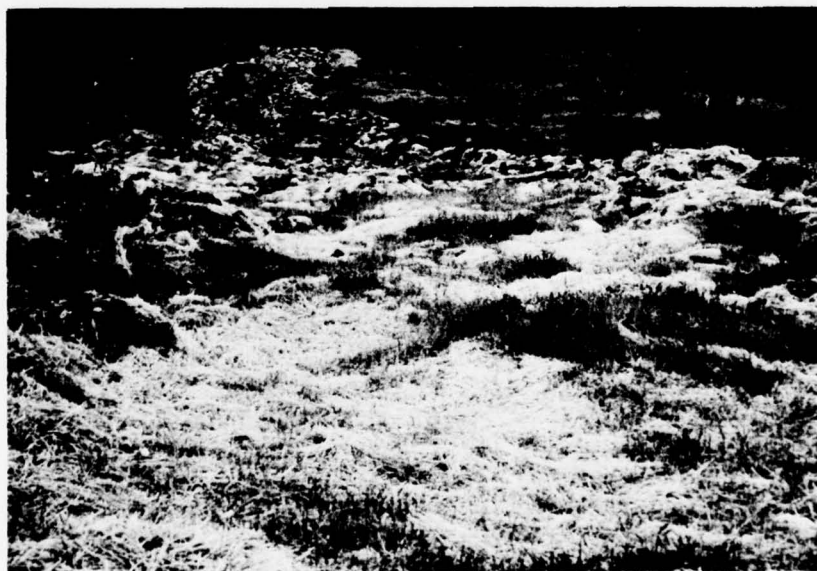
Plate 8. A.S. 108: View looking down slump. Stabilized with hay and excelsior matting.

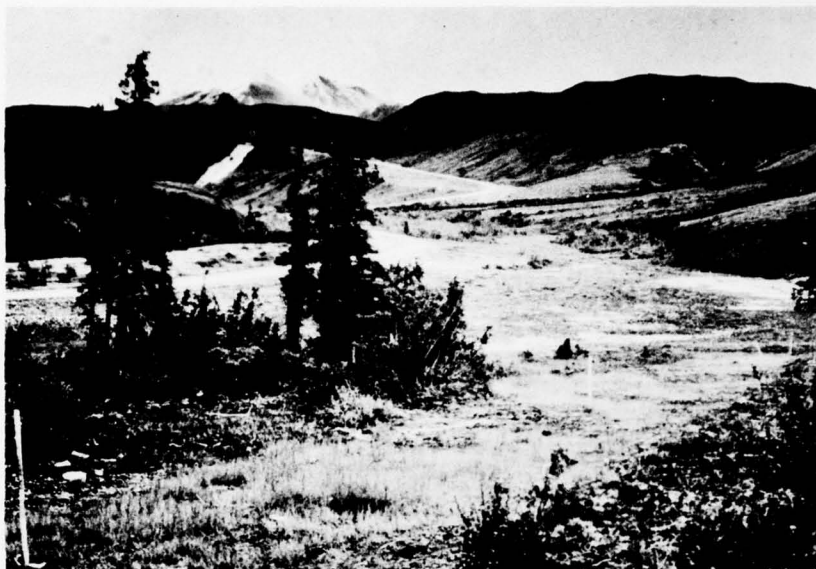
Plate 9. A.S. 108-109. Revegetated winter trail to east of road.

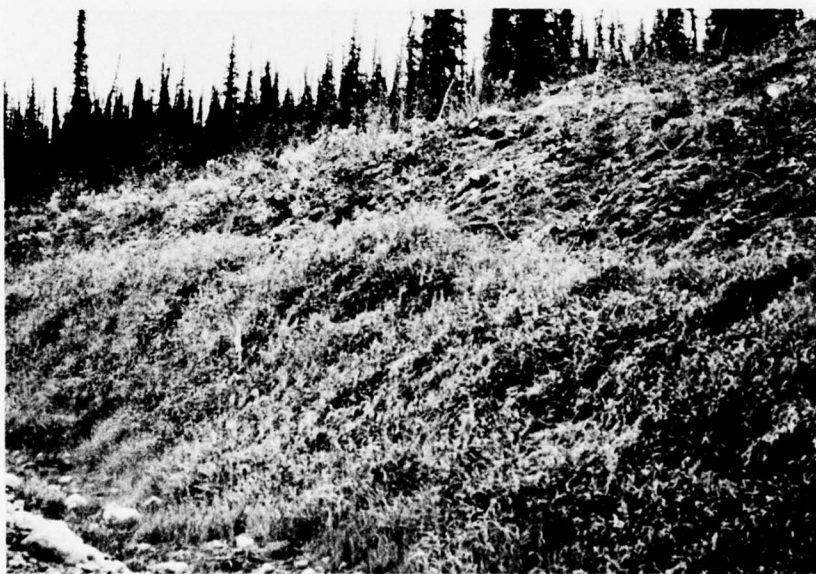
Plate 10. A.S. 107 (Station 35732): Organic mat folding over road cut. Trees were cut above the road cut to avoid shearing of the slumping organic mat.

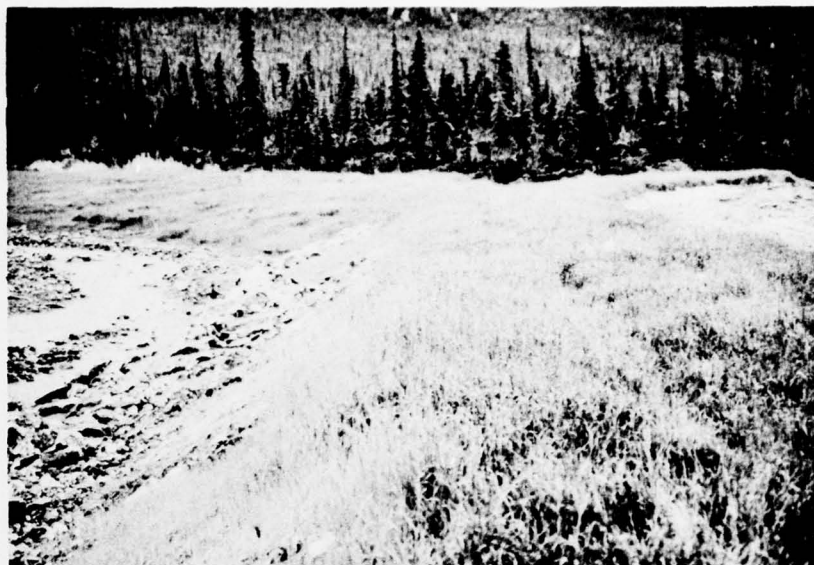
Plate 11. A.S. 104 (Station 2809+09): Lush stand of annual rye, along Unnamed Creek bank. Heavily grazed by moose in September.

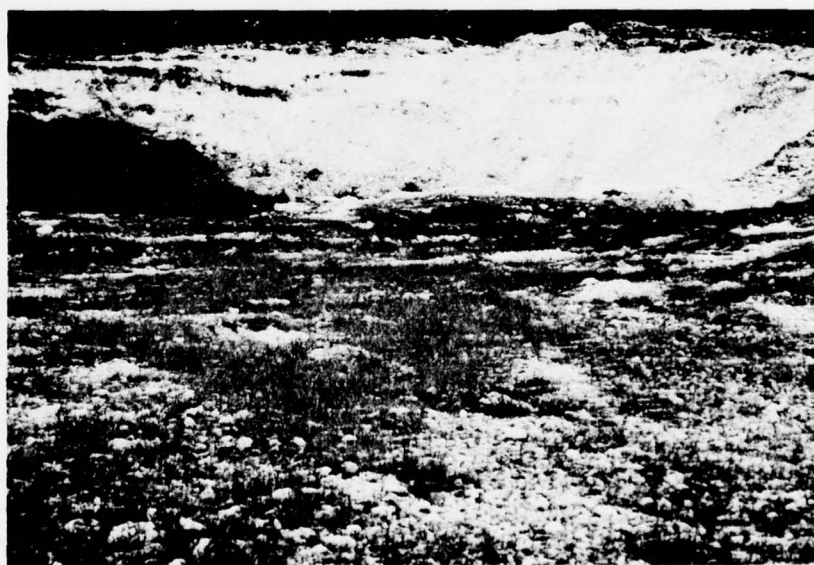
Plate 12. Material site 103-0.1: The area at base of Suk-akpak Mountain was revegetated but aesthetics may dictate natural vegetation be used instead. Cover 30-80% rye over gravelly substrate.

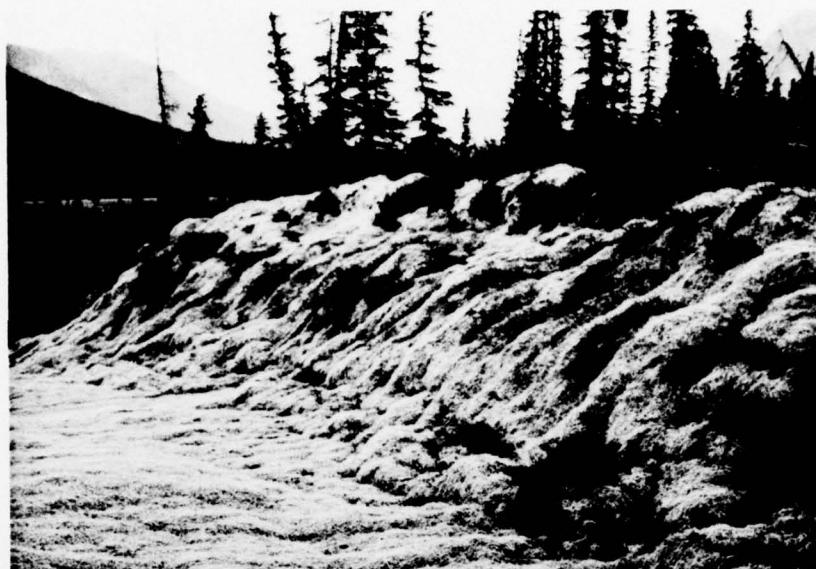
Plate 13. A.S. 102: Excelsior mats used to stabilize hand seeded cut on east side of work pad; growth mostly annuals.

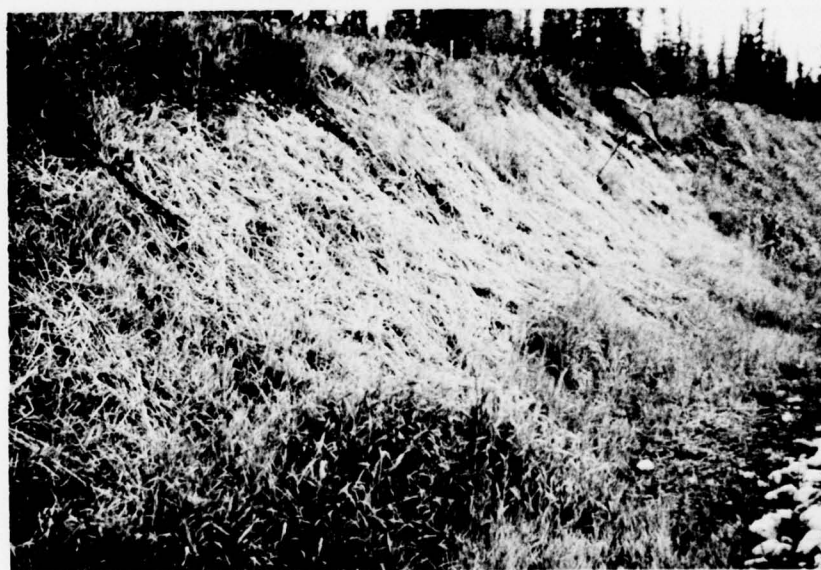
Plate 14. A.S. 101: Straw mulch and hydroseeded Haul road cut.

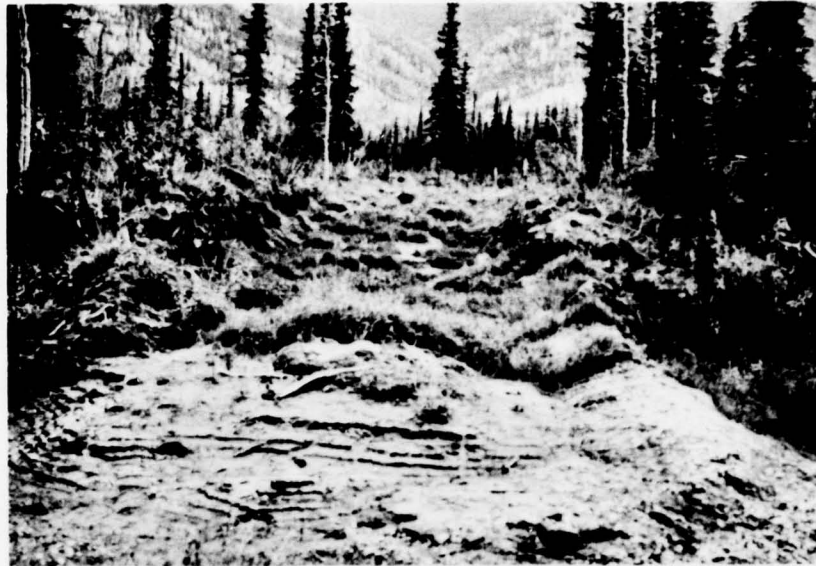
Plate 15. A.S. 100: Abandoned and bladed trail was seeded and mulched with hay just north of Middle Fork Koyukuk.

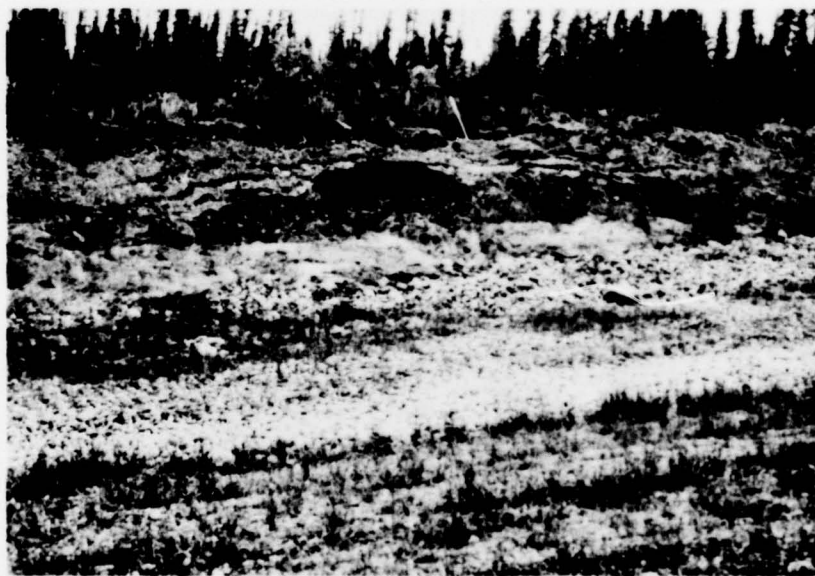
Plate 16. A.S. 97: Ice cut exposed by road cut and unseeded as of September 1975.

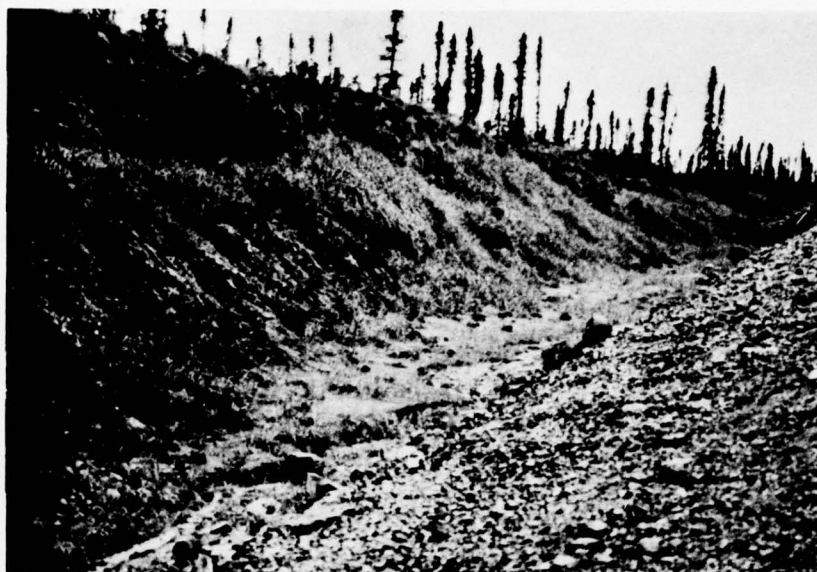
Plate 17: A.S. 91: Hydroseeded road cut with overhanging mat and some tussocks and black spruce.

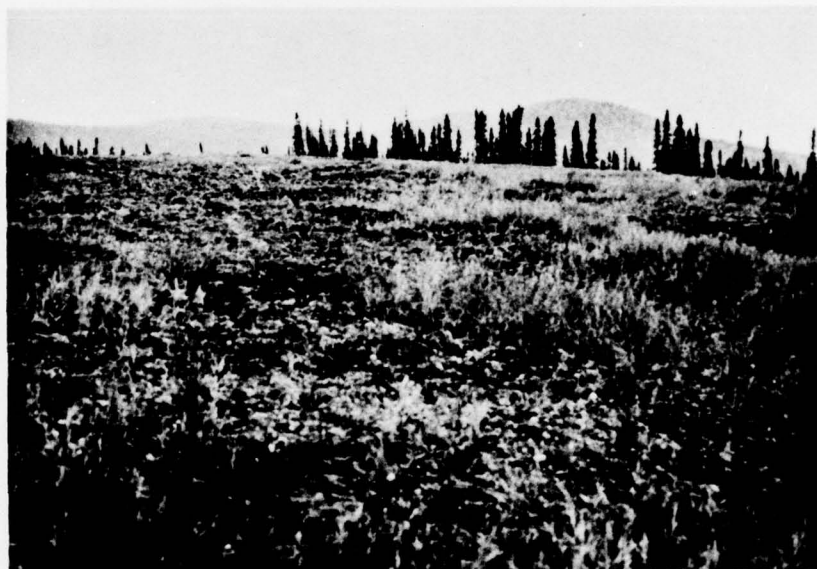
Plate 18. M.S. 91-3: Material site probably reseeded in 1974 and having 10-20% cover of annual rye, meadow foxtail, fescue, and fireweed.

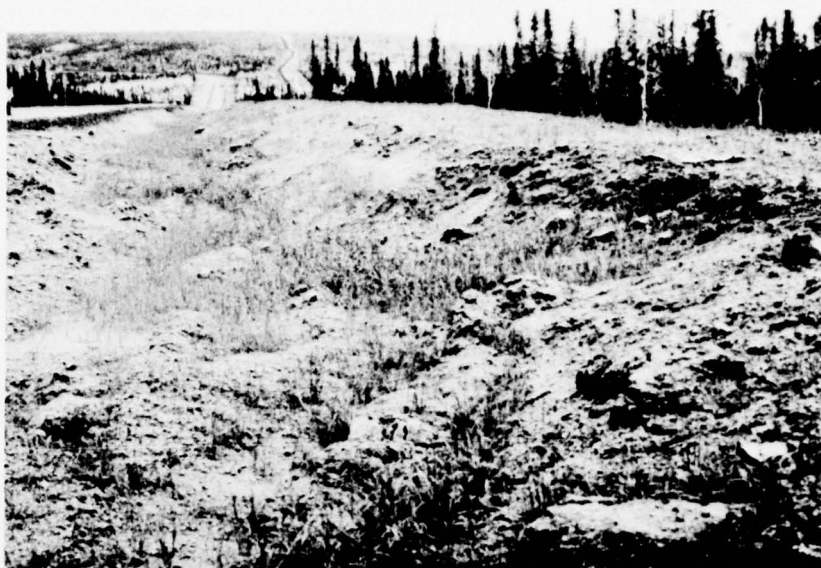
Plate 19. A.S. 90: Hydroseeding over weathered granite substrate.

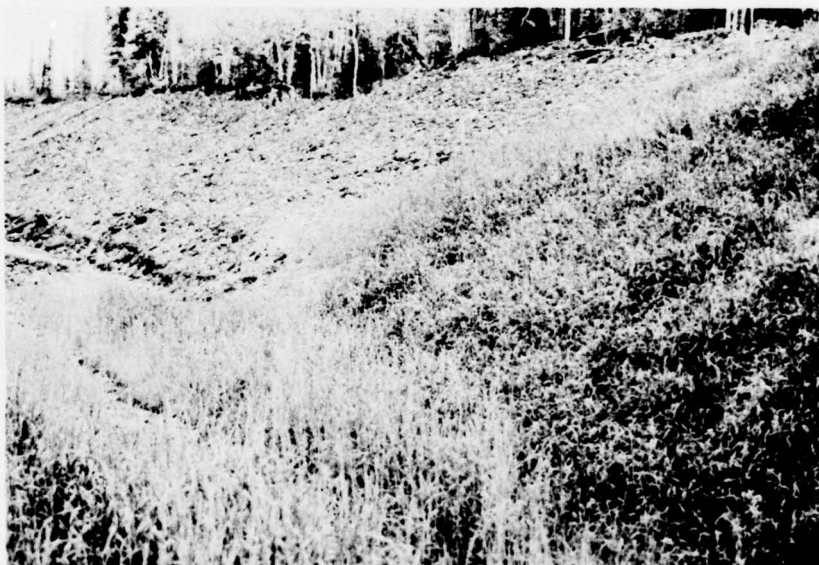
Plate 20. A.S. 88: East side of road cut, one-third of it seeded with good cover in 1975.

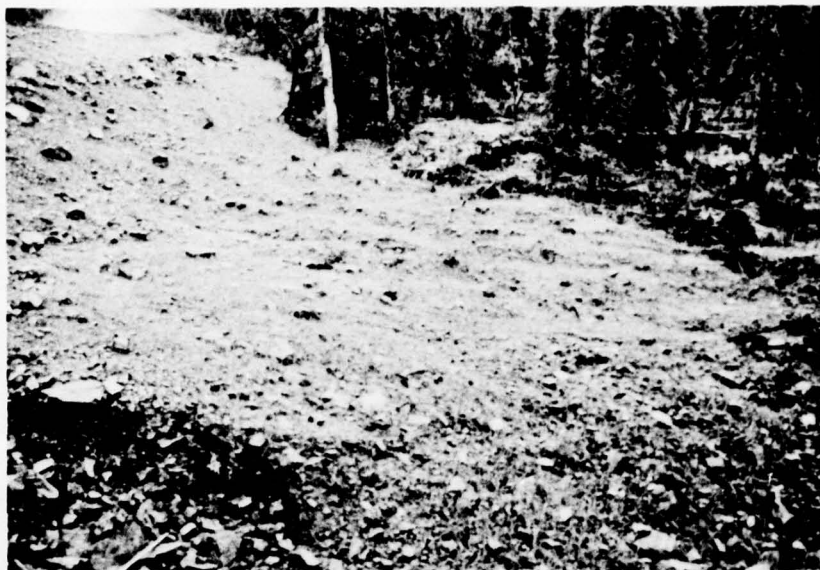
Plate 21. A.S. 84: West side of road hydroseeded with wood fiber mulch (beside a stream). Some barley and chenopods germinating from hay.

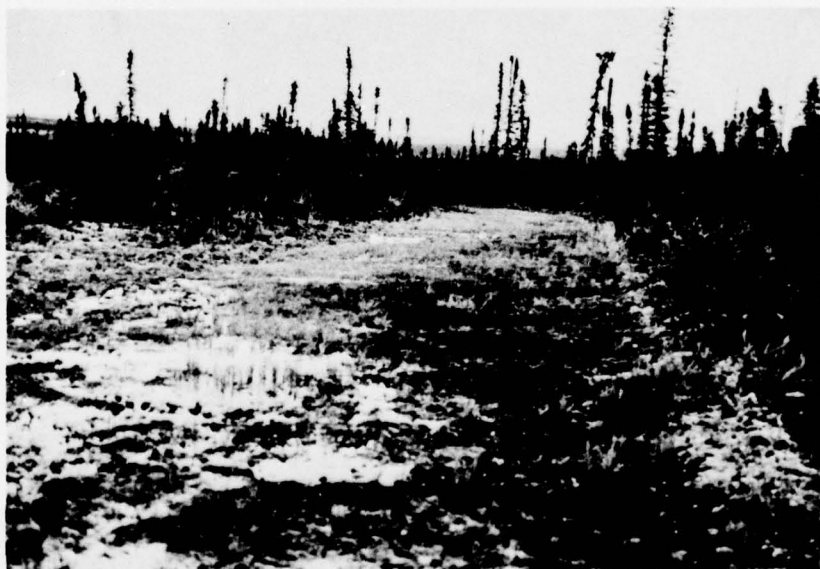
Plate 22. A.S. 81-82: Winter haul road on east side seeded, just south of No-Name Creek. Cover 10% on organic substrate and 20% on more sandy substrate.

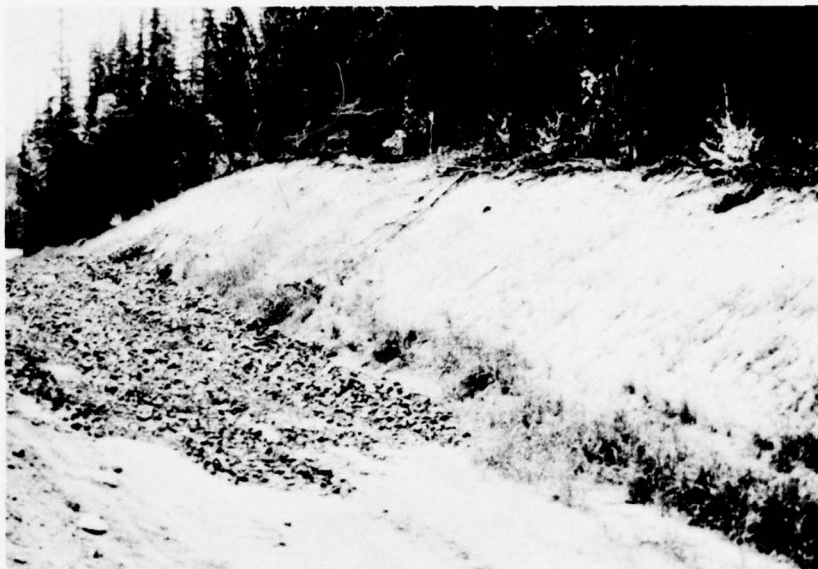
Plate 23. A.S. 80: Roadcut seeded on east side of Haul road north of 80-3.1. Germination very low on upper slope.

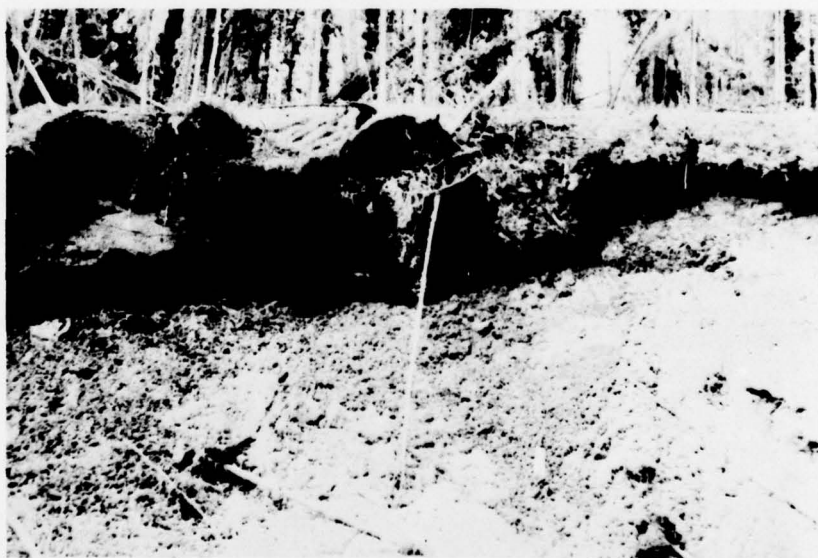
Plate 24. Ice cut at south abutment of Yukon Bridge. Large ice lenses in silt exposed by road cut. Trees left in place on vegetative mat are tearing the mat as they are undercut by thaw.

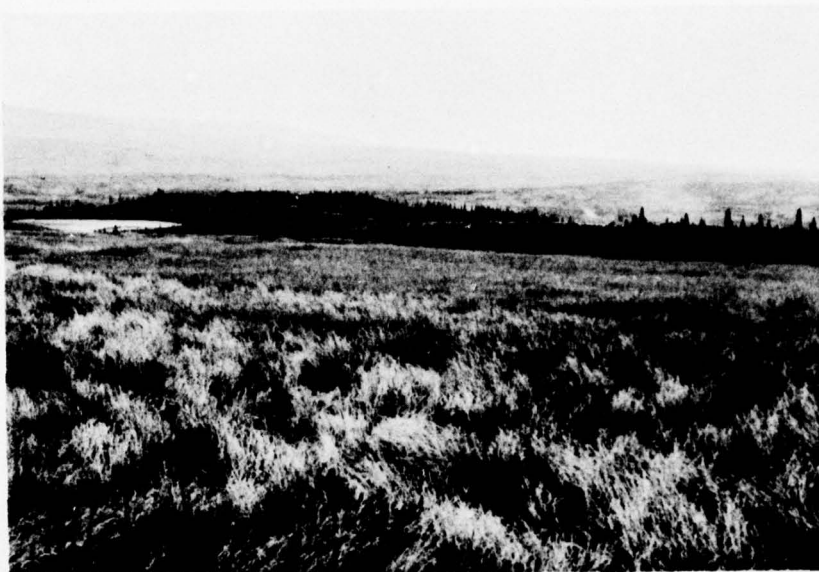
Plate 25. Pump Station 6: Large disposal area of wet silt north of station was aerially seeded in May, producing a lush growth of annual ryegrass. Some areas of coarse gravel shoulder were sparsely seeded using wood fiber mulch. (Disposal site 77-48.)

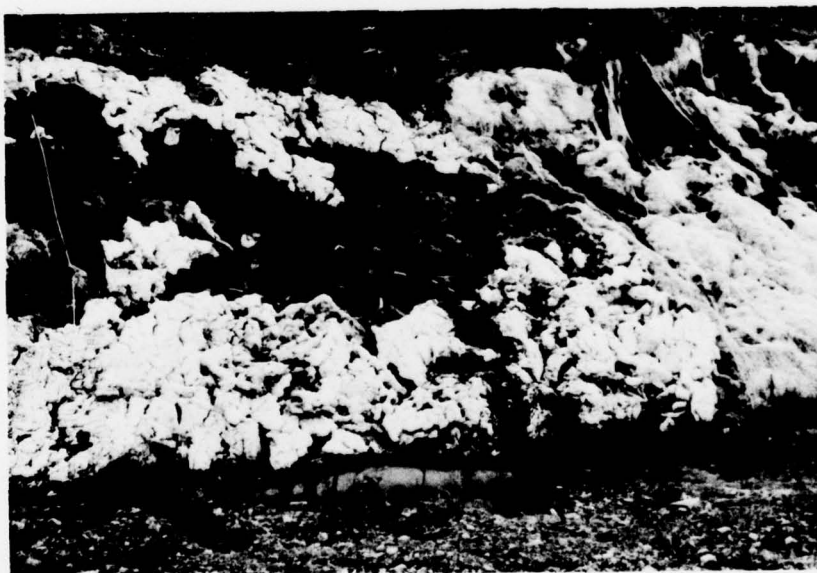
Plate 26. Mile 20.2 on Haul Road: Experimental plots on road cut treated with urethane foam and plastic nets.

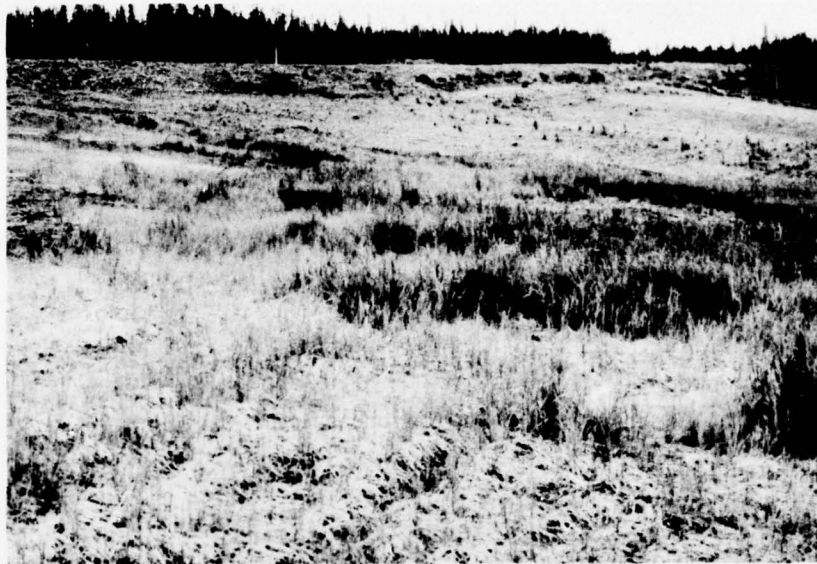
Plate 27. Mile 19.3 on Haul Road: Lower portion hydroseeded.

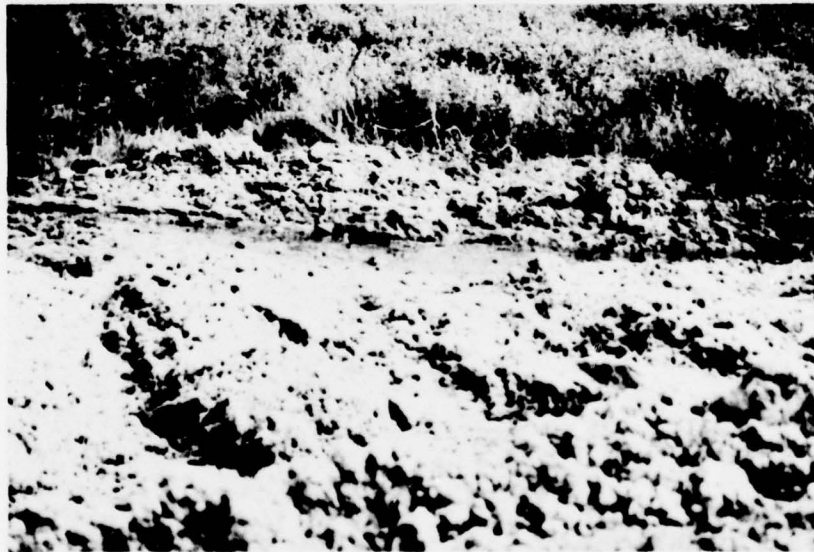
Plate 28. A.S. 66: MP 418 hydroseeded cut. Workpad was soft; several seeps appeared on work pad surface. Potential problems with icings and groundwater flow down trench.

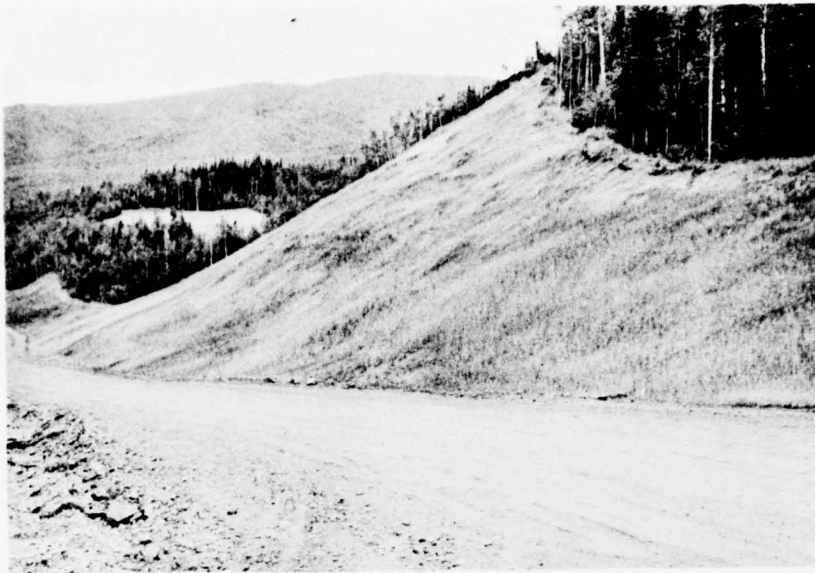
- *30. A.S. 51: Massive sandy slopes in vicinity of Rosa Creek. Hay and netting used to stabilize slopes as well as hydroseeded slopes in pipe storage yard and along access road. (Plate 29)
31. A.S. 48: About 1 mile north of Tanana River, road cuts in ice-rich silt, hydroseeded and hay mulched. Tractor had been run up and down the side slope to produce depressions for holding seed and moisture. (Plate 30)

Plate 29. A.S. 51: Massive sandy slopes in vicinity of Rosa Creek. Hay and netting used to stabilize slopes as well as hydroseeded slopes in pipe storage yard and along access road.

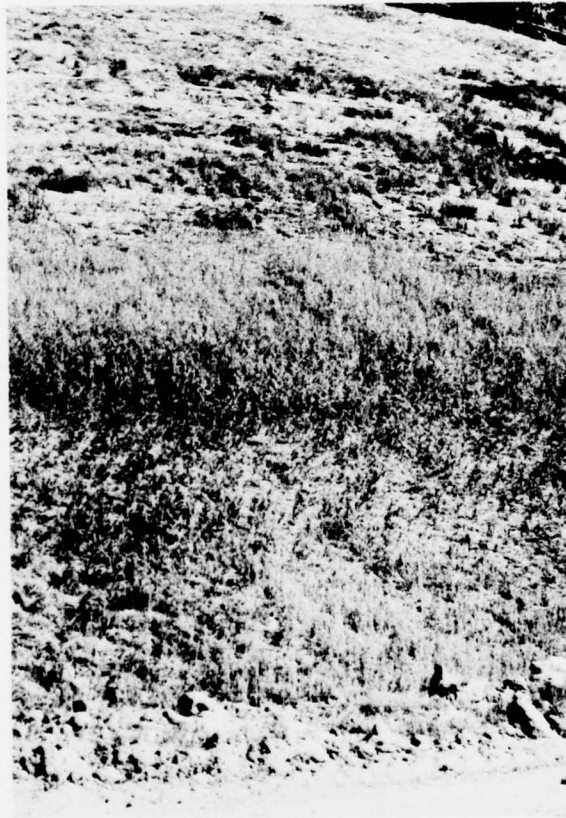
Plate 30. A.S. 48: About 1 mile north of Tanana River, road cuts in ice-rich silt, hydroseeded and hay mulched. Tractor had been run up and down the side slope to produce depressions for holding seed and moisture.

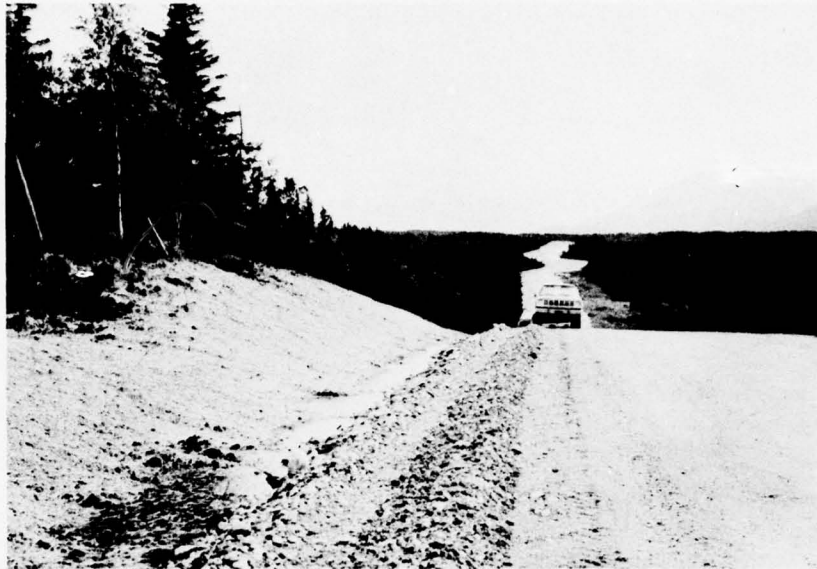
Plate 31. A.S. 42 and 41: Numerous cuts on sides of workpad hydroseeded in alpine area near Donnelly Dome.

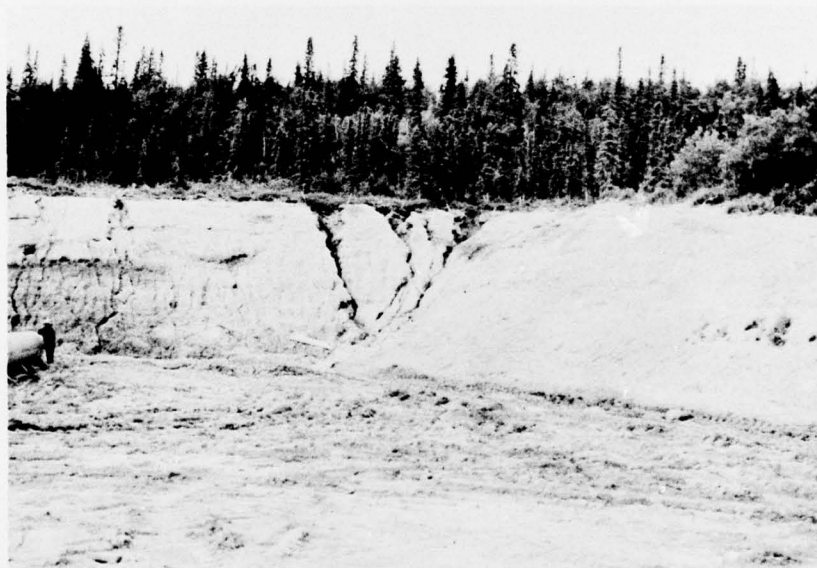
Plate 32. A.S. 28: Large pipe storage yard 2-1R north of Hogan Hill. Some erosion gullies despite hydroseeded slopes. Considerable amount of waste silt had flowed toward Haggard Creek in spring. Dikes used to contain waste silt.

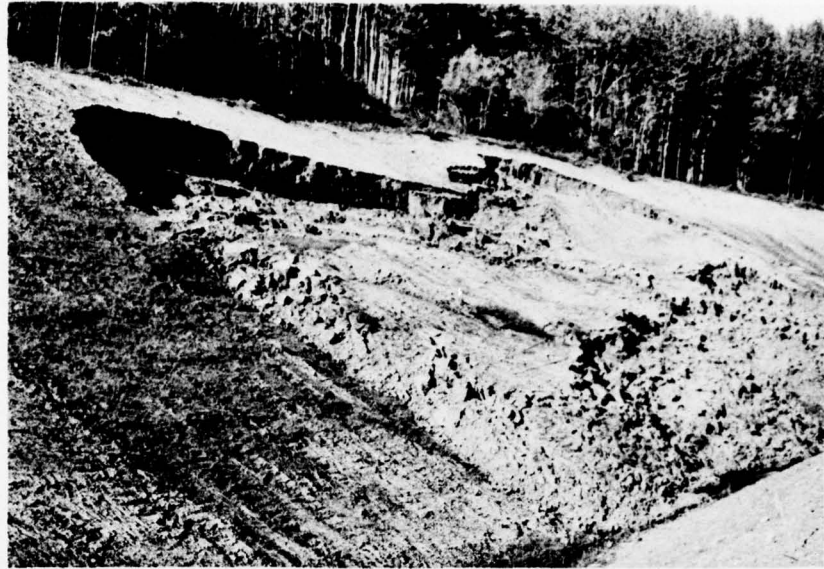
- *34. Pump Station 11: Massive deep seated slope failure. Failure began about mid June after a period of heavy rainfall. Some additional sliding occurred about mid-July. Seeded latter part of June. (Plate 33)

Plate 33. Pump Station 11: Massive deep seated slope failure. Failure began about mid-June after a period of heavy rainfall. Some additional sliding occurred about mid-July. Seeded latter part of June.

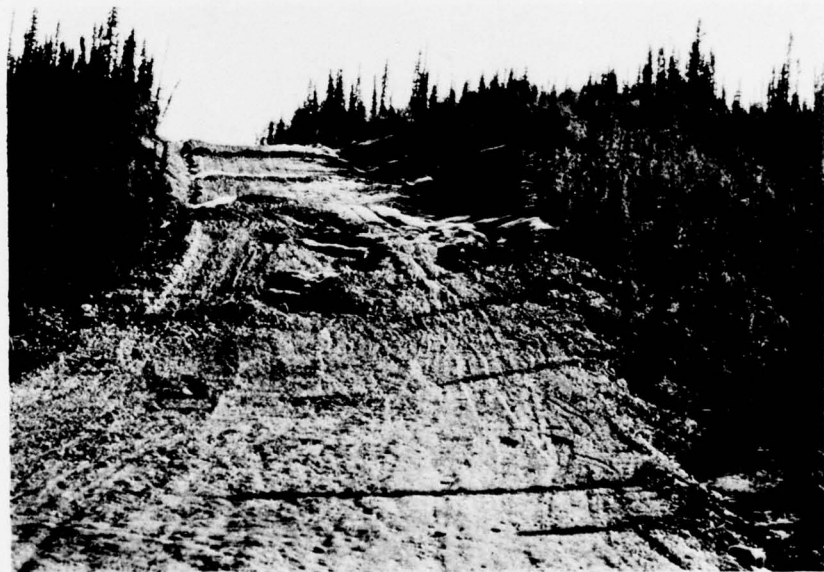
Plate 34. A.S. 18.1: Ice-rich soils exposed and eroding despite gravel overburden and thick hay mulch.

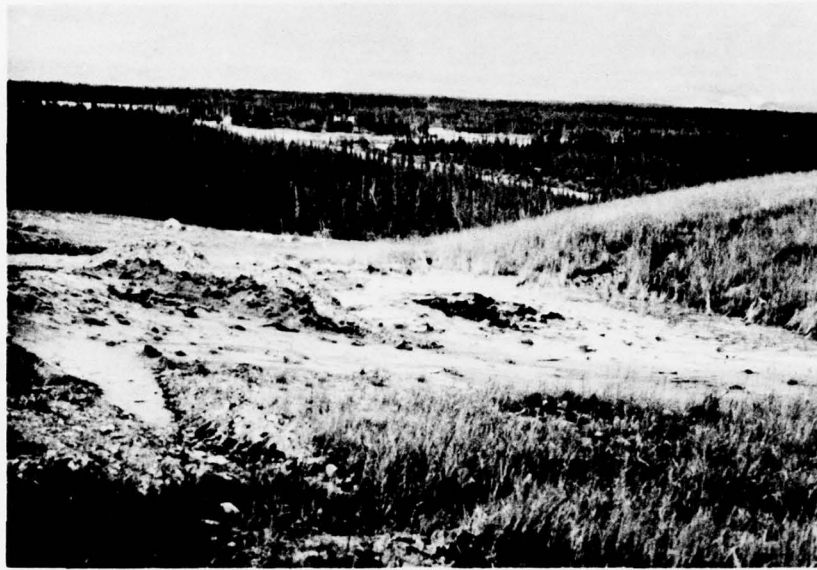
Plate 35. Material Site 17-5: Disposal materials used to cover gravel and then reseeded. Upper area had almost 100% plant cover.

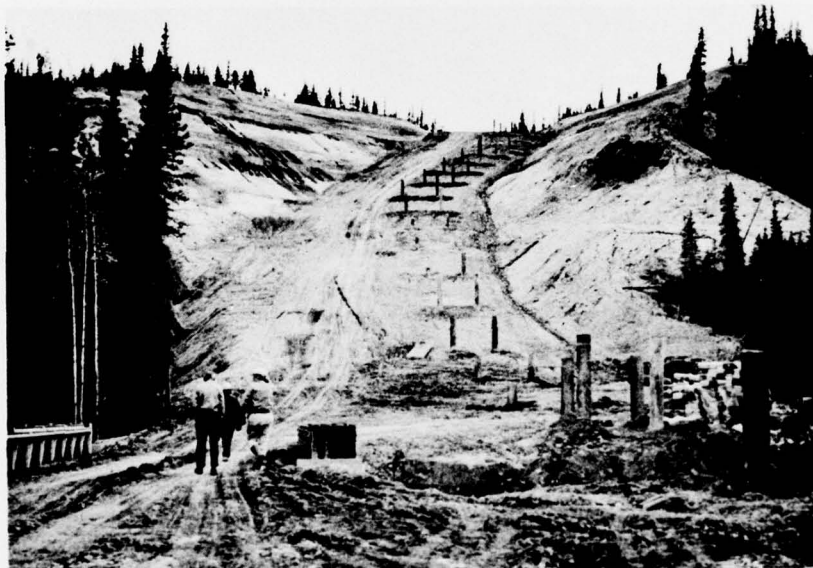
Plate 36. A.S. 16: Steep slope on south side of Squirrel Creek. Some erosion still evident. Wood fiber mulched at 2000 to 2500 lbs/acre. Additional erosion control efforts were planned in 1975.

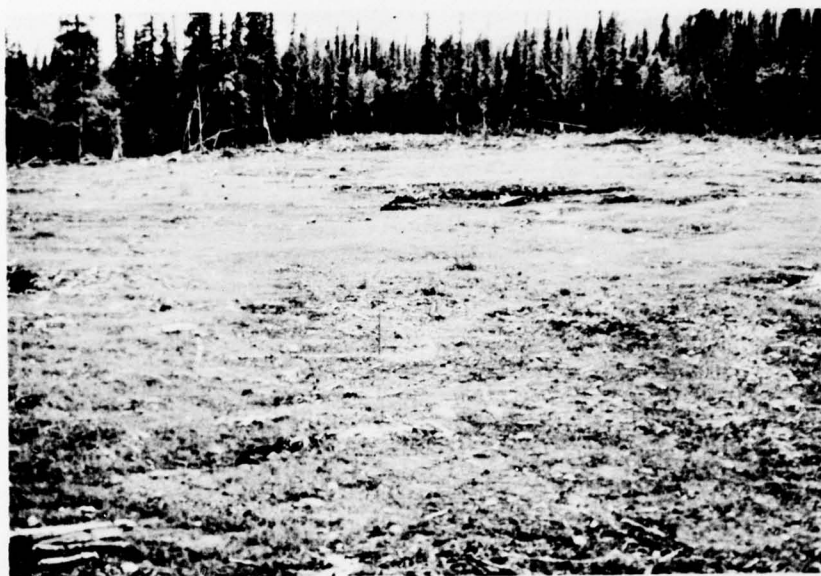
Plate 37. Disposal site 16-1: Brush covered with soil, wood fiber mulched and reseeded. Reasonable growth by mid-summer with willow and fireweed recolonizing.

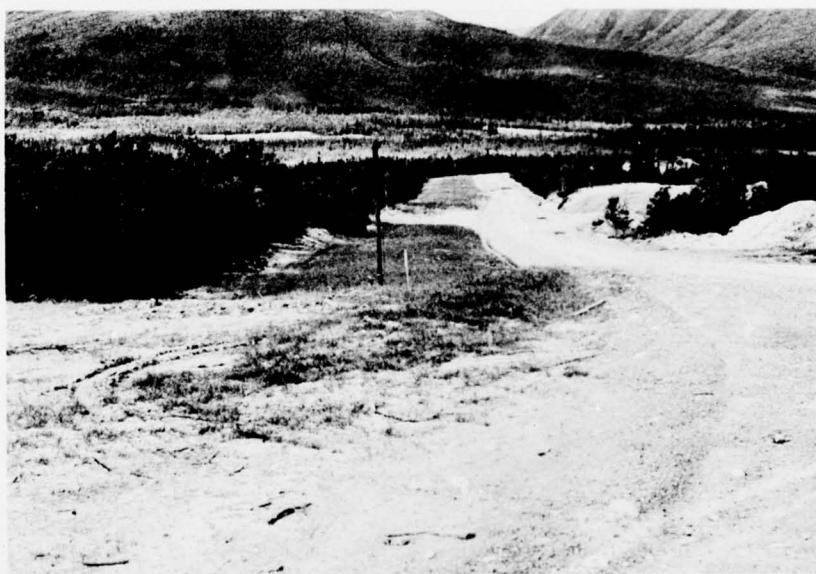
Plate 38. North of Pump Station 12: Intersection of workpad with Richardson highway. Entire width of workpad seeded over buried pipe.

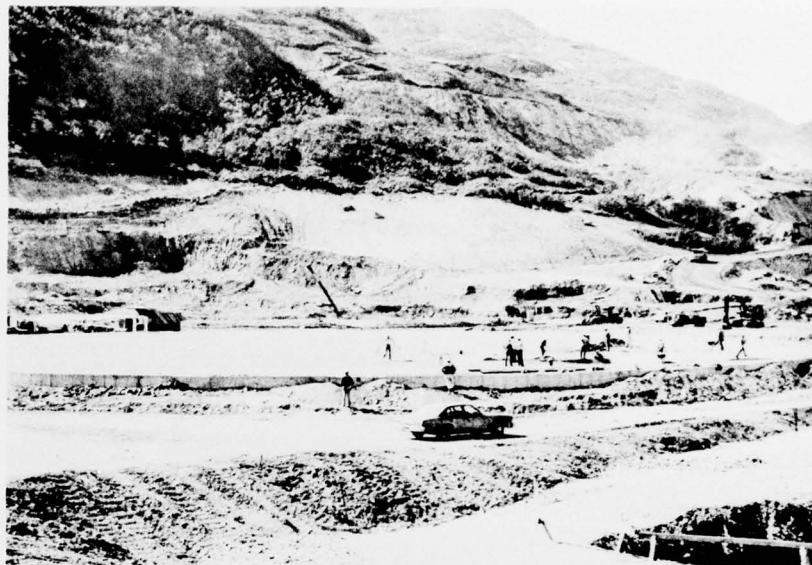
Plate 39. Valdez Terminal: Areas hydroseeded.
